**SUMMERVILLE
COMMUNITY DEVELOPMENT
DISTRICT**

**MIAMI-DADE COUNTY
REGULAR BOARD MEETING
JUNE 4, 2025
9:00 A.M.**

David M. Waddell Consulting, Inc
ISA Certified Arborist
14721 SW 148 Ave.
Miami, FL 33196

My assignment was to inspect and evaluate the ornamental trees under the CDDs control and prepare a 3-year mitigation plan to regulate tree growth-related infrastructure problems and tree long term sustainability and aesthetics. Prepare a Master map spreadsheet to include location, tree description, photograph each tree and mark mitigation to be taken. Prepare projected estimated costs of removal/replacement, root barrier installation and removal/replacement spreadsheet for DERM tree removal application.

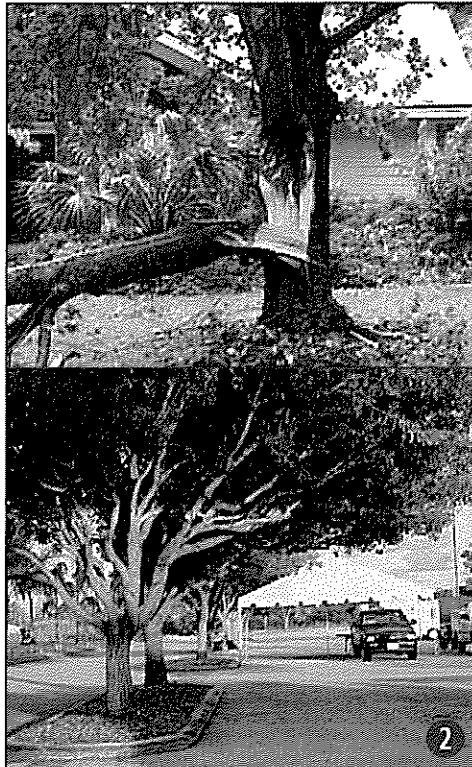
Figure 2

The codominant stem (top) split from the tree because of a weak branch connection and included bark. Proper structural pruning could have prevented this defect from failing. The large lower limbs (bottom) of these mahogany trees are too close to the ground and will have to be removed soon to provide for clearance under the canopy. Removing large branches like this can initiate decay and slows growth. Prune earlier to prevent this poor form from developing.

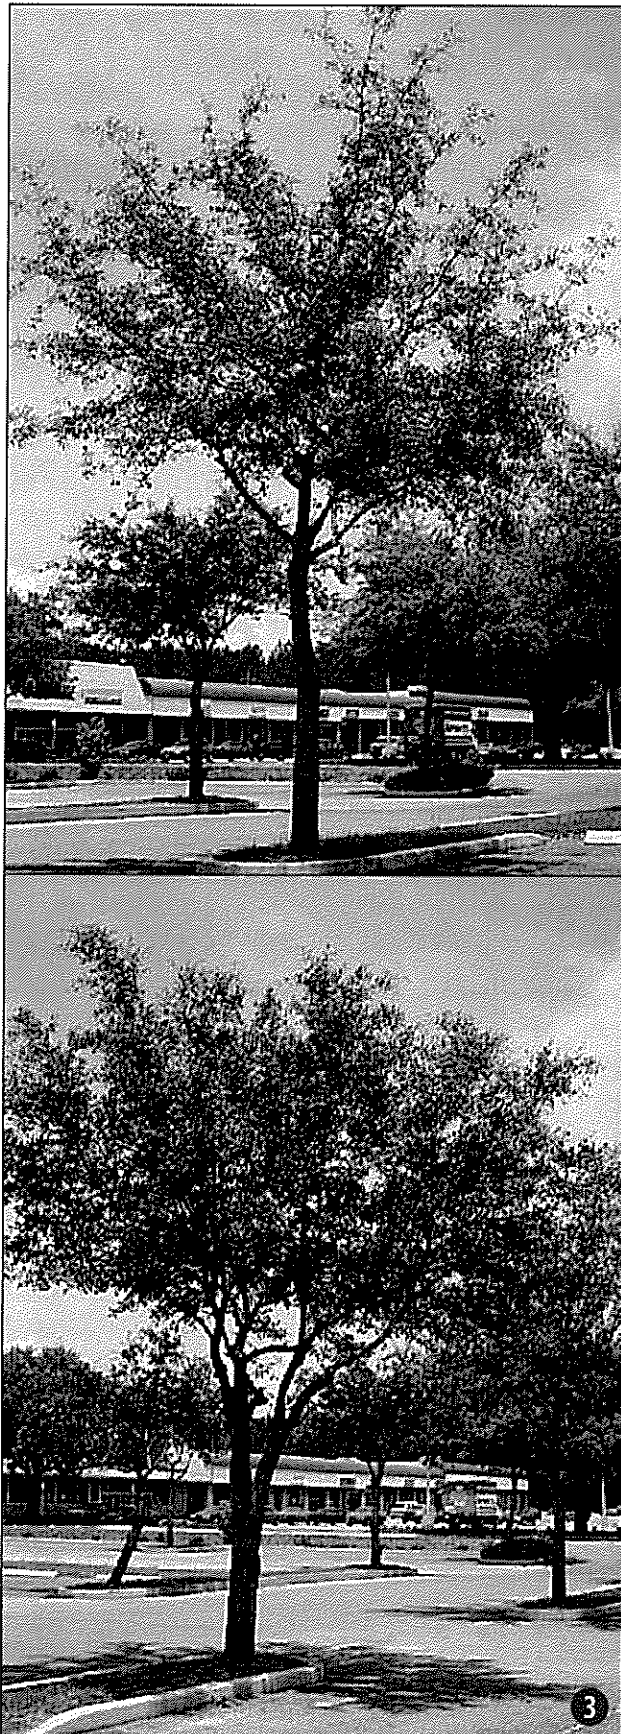
Figure 3

A good structure (top) is characterized by a single dominant leader, and branches that are spaced and not touching throughout the canopy. A bad structure (bottom) has many dominant stems and branches clustered together.

Trees with good structure are characterized by a single dominant leader, strong branch unions without bark inclusions and a balanced canopy (Figure 3). Preventive or structural pruning is a process that can help to promote these attributes in trees.

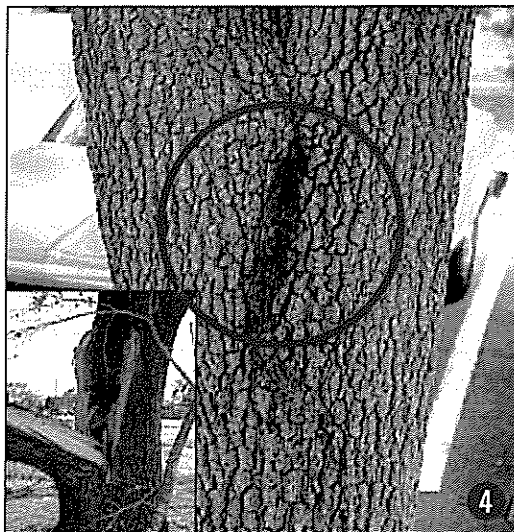
Figure 4

Codominant stems with included bark have weak connections and often split apart in storms (inset).

Codominant stems are stems of equal size originating from the same point on the tree. Included bark is bark pinched between two stems creating a weak union. Codominant stems with a 'V' shaped union are often accompanied by included bark (Figure 4). This union is weak because the bark inclusion prevents any physical connection between the two stems. Instead of overlapping wood creating a strong connection, the two stems push each other apart as they grow and a crack develops. Researchers at the University of Florida have visited several hurricane sites, and found time and time again that trees failed due to structural issues like codominant stems and bark inclusions.

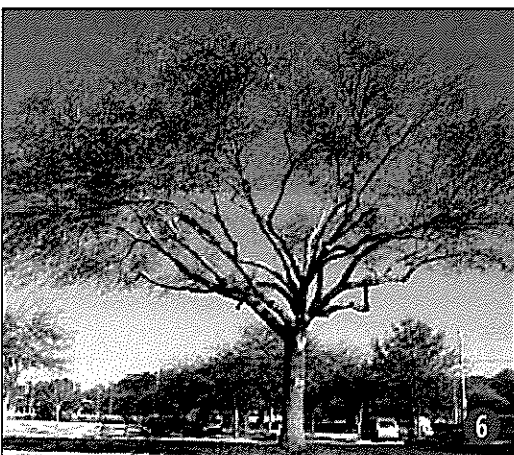
Figure 6

Lions-tailed trees have an unbalanced canopy since all of the foliage is at the tips of the branches. These trees are more susceptible to storm damage and difficult to restore once they are damaged.

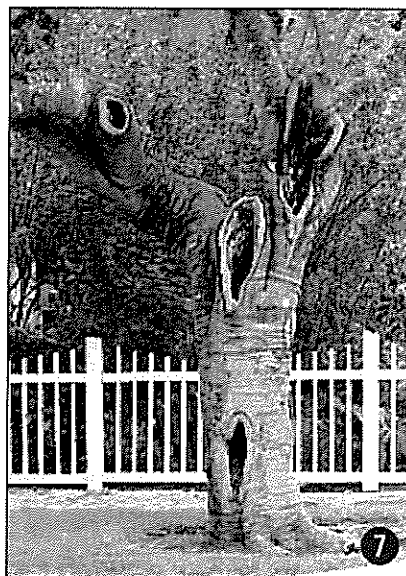
Figure 7

Large pruning cuts can initiate pockets of decay in the trunk.

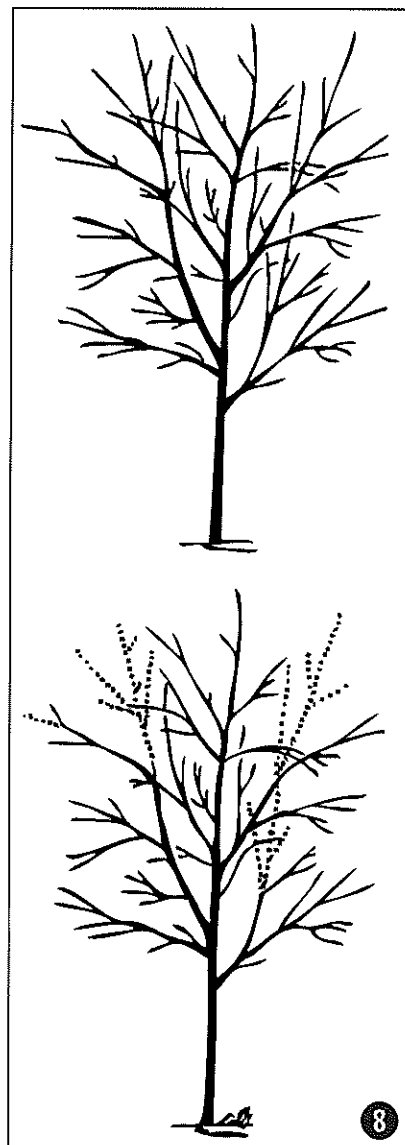
Figure 8

Pruning the stems represented by the dotted lines shortens two of the three codominant stems. This helps establish a single dominant leader in this young shade tree.

Developing a dominant leader starts by identifying the stem that will make the best leader; typically it is the largest stem. This might be easy for some trees and more difficult in others. If all stems are about the same diameter, pick the one that is closest to the center of the canopy as the leader. Then determine which stems are competing with that leader, and decide where to shorten these competing stems (Figures 8 and 9).

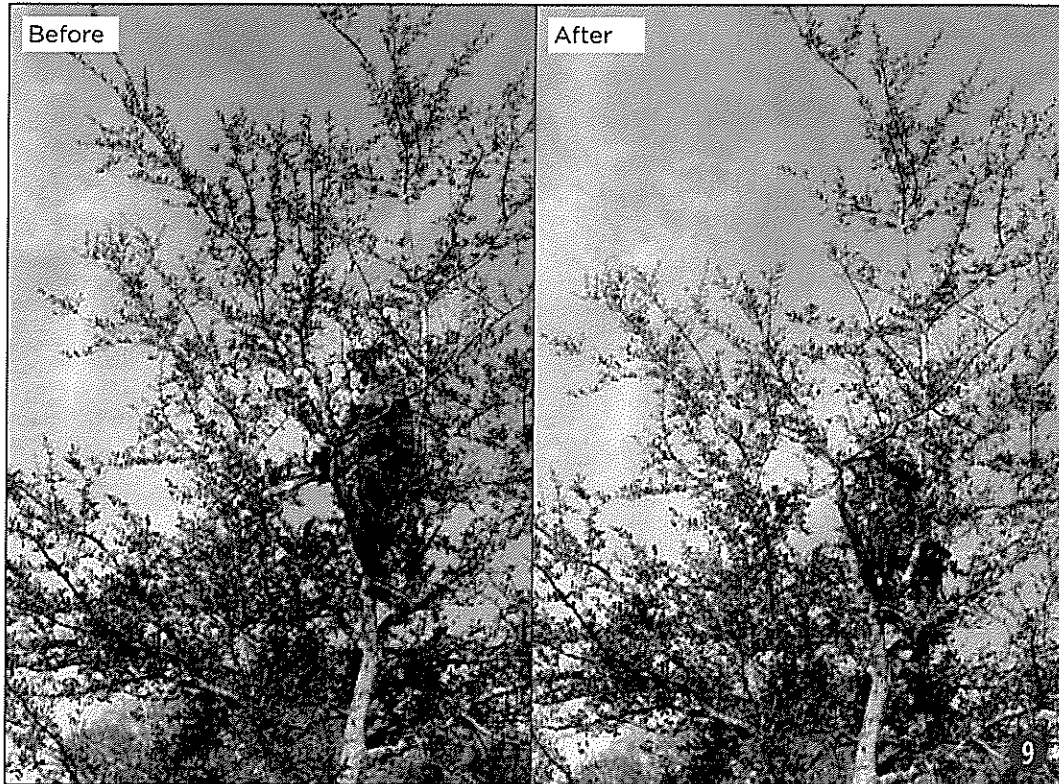
Figure 9

Before and after structurally pruning a young live oak. Notice the arrow indicating where the stem on left side of the leader has been reduced.

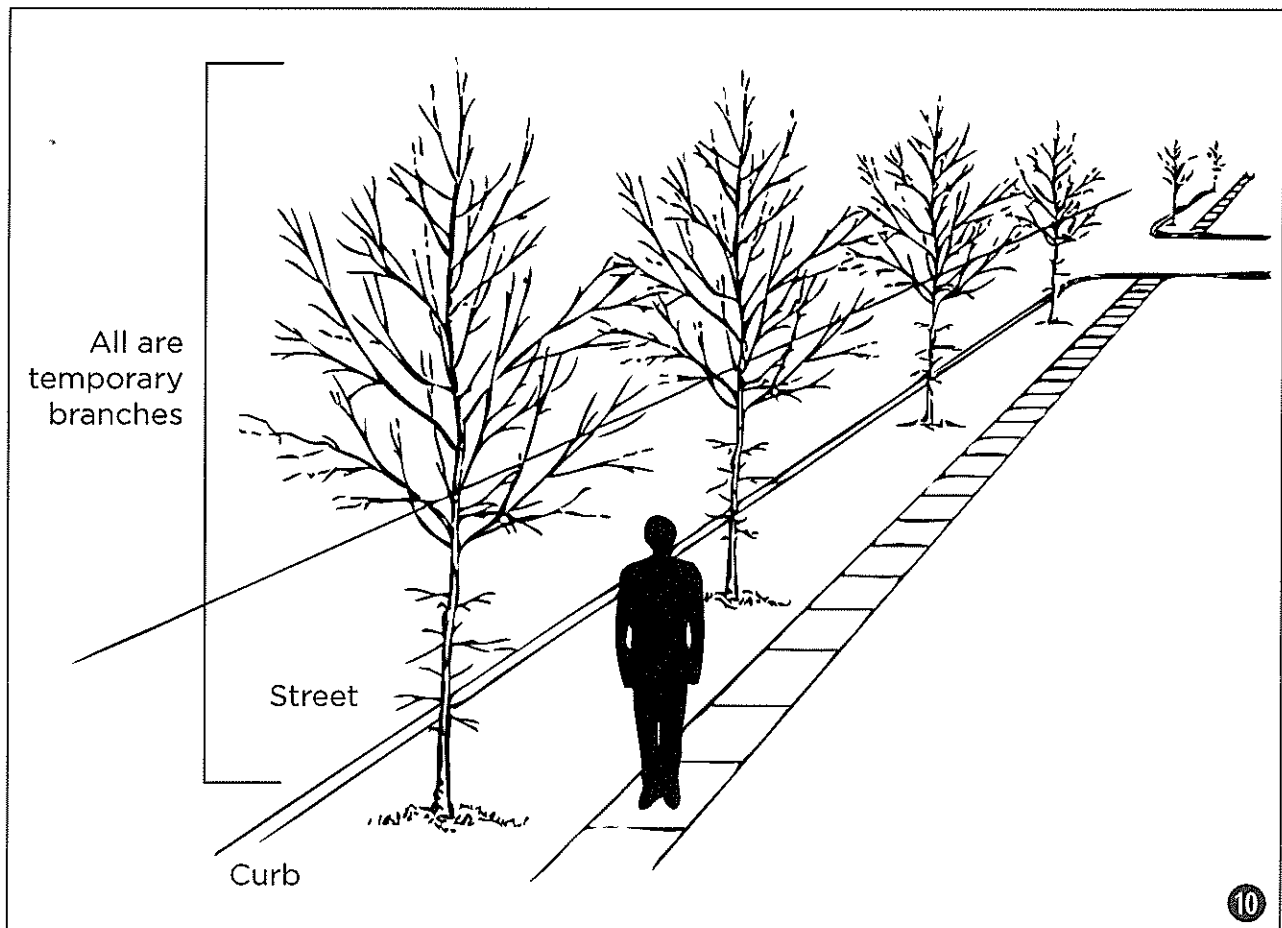
Figure 10

All existing branches on these recently planted trees along a street will eventually have to be removed in order to provide clearance for buses, garbage trucks, and tractor trailers.

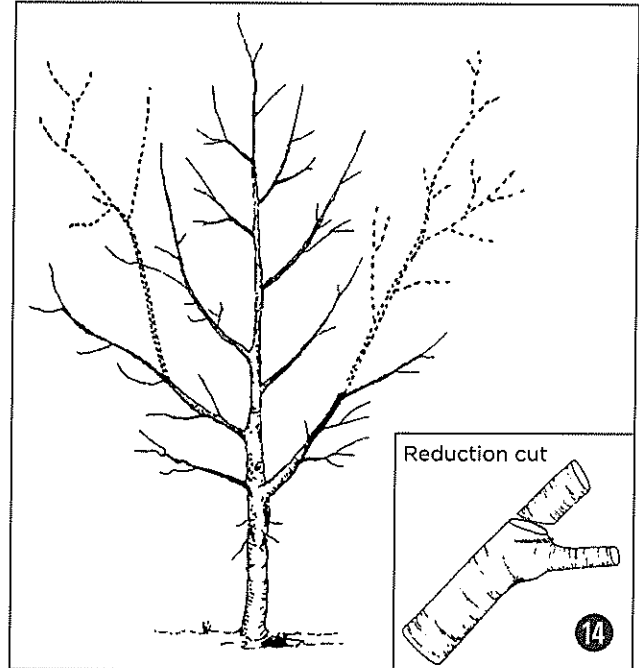
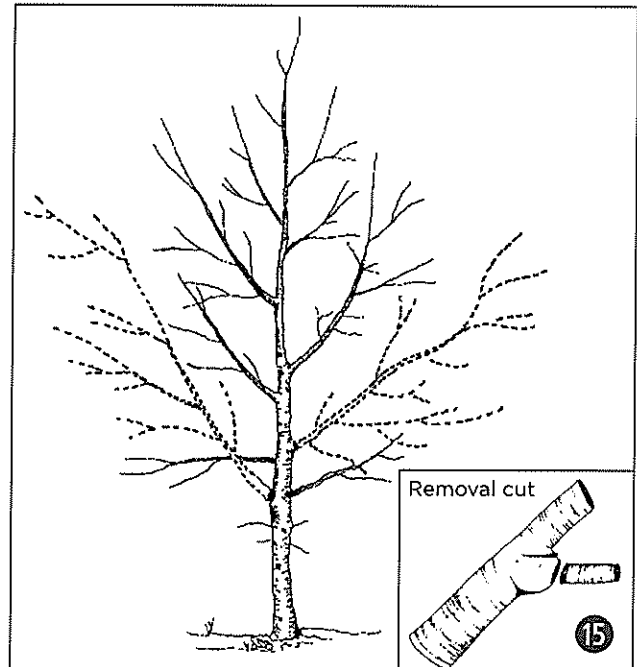
Figure 14

A reduction cut shortens the length of a stem by pruning back to a smaller limb large enough to assume dominance.

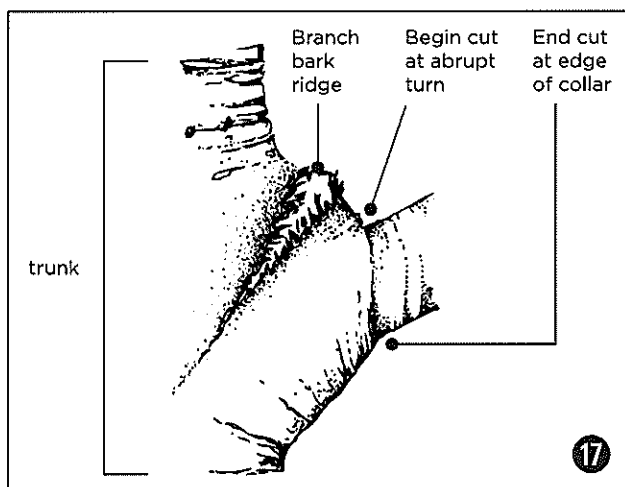
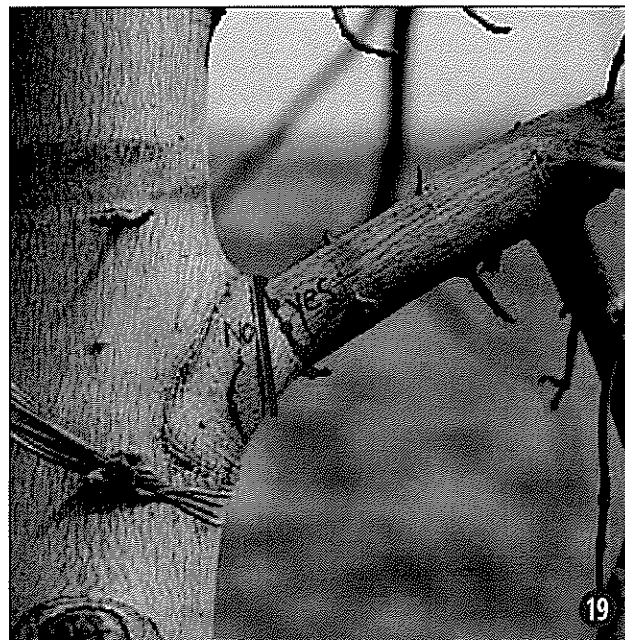
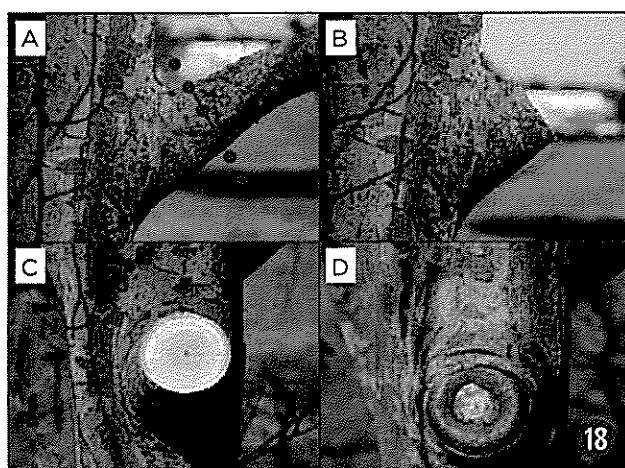
Figure 17

A close-up illustration showing where to make a removal cut.

A good pruning cut begins with an undercut about 12 inches from the trunk (Figure 16). A top cut is then made further out from the limb or directly above the undercut. The majority of the limb is safely removed in this step without causing any damage to the tree. (Disregarding these first two steps could cause damage to the trunk because the branch is often too heavy to hold itself up causing tissue to tear down through the collar.) The last step is to remove the remaining stub with a final cut, being careful not to cut flush against the trunk. It is very important to leave the collar intact (Figure 17). A branch collar is a swollen area at the base of the branch where it joins the trunk. The tissue is rich in energy reserves and chemicals that hinder the spread of decay. Good pruning cuts avoid cutting into the collar and typically leave a round-shaped wound, whereas flush cuts are oval-shaped (Figure 18). The branch bark ridge is where trunk bark pushes up into the union as it grows against branch bark (Figure 19). This indicates a strong union. Never cut off the branch bark ridge since this removes the branch protection zone inside the collar. The protection zone helps prevent decay organisms from entering the trunk.

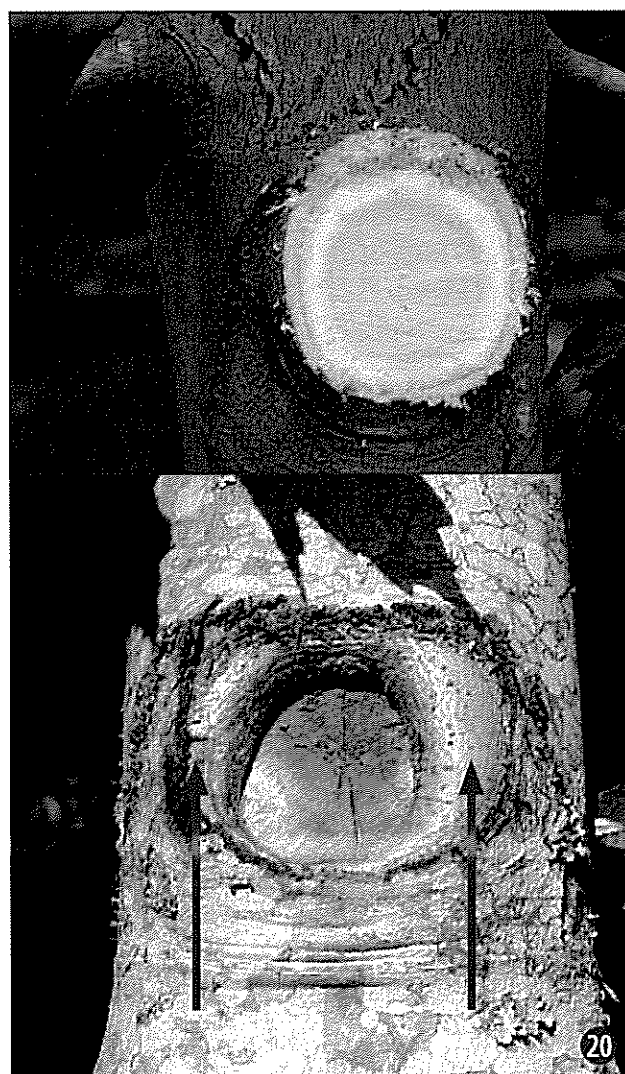
Figure 20

Flush cuts remove the top of the branch bark ridge, and typically expose more bark on top of the cut than on the sides and bottom (top). Flush cuts prevent the wound from sealing over properly, and typically close first on the sides then on the top and bottom (bottom). Severe decay can occur behind flush cuts, especially large ones.

Bad cuts are called flush cuts and are unacceptable in a preventive pruning program (Figure 20). Flush cuts remove the top of the branch bark ridge, and prevent the wound from sealing over properly. Flush cuts typically expose more bark on top of the cut than on the sides and bottom. These cuts typically close first on the sides then on the top and bottom. Severe decay can occur behind flush cuts, especially when they are large in diameter.

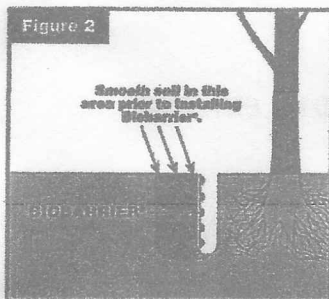
- Smooth soil surface to desired FINAL GRADE LEVEL on side of trench opposite root source (see Figure 2).

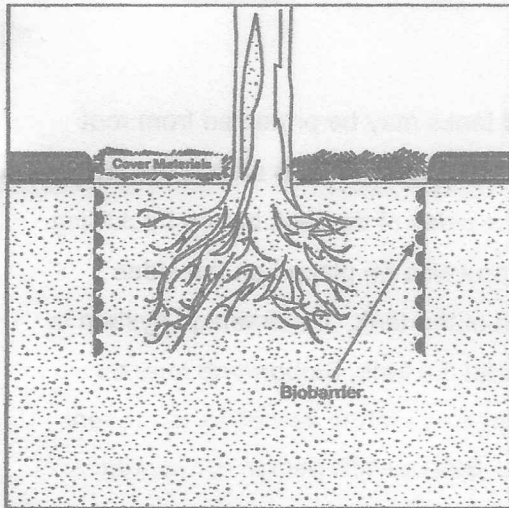
Sidewalks/Paths/Streets/Curbs/Medians/ Tennis Courts

Dig a trench adjacent to hardscape (as close as possible) insuring depth is below where existing roots are found. After trenching, remove remaining roots, leaving walls of trench smooth. Place top edge of Biobarrier® at finished grade level, securing with installation strips and/or pins provided. Backfill carefully to avoid dislocating Biobarrier®, and compact firmly.
